# TAILORED

HOME IMPROVEMENTS

**Roof Authority Report**  
13 Sesame St,  
Kanata, ON K2K XXX

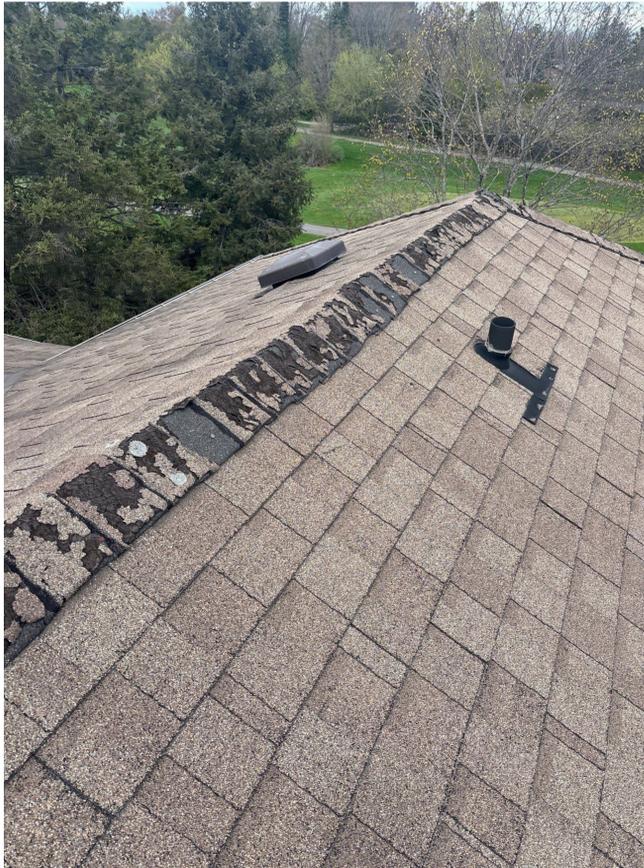
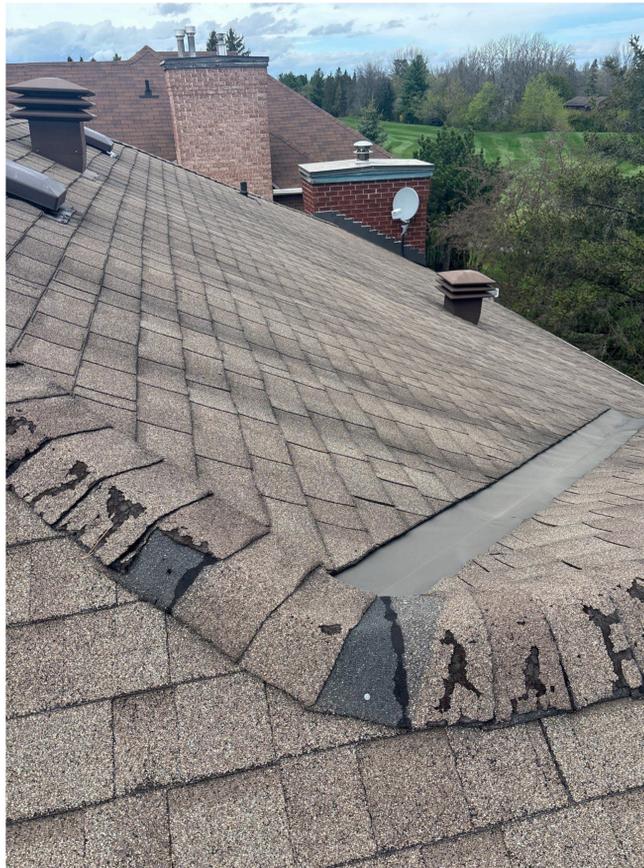
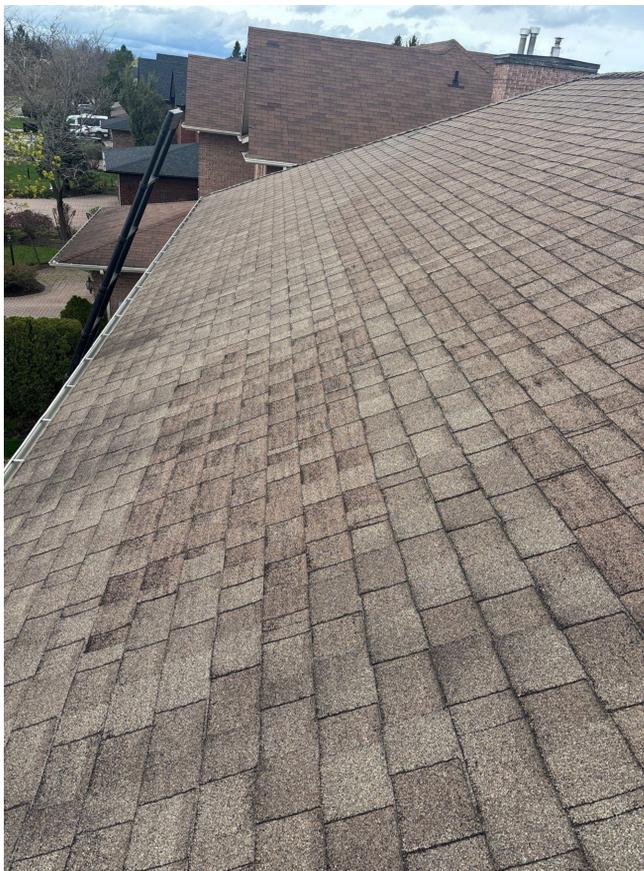
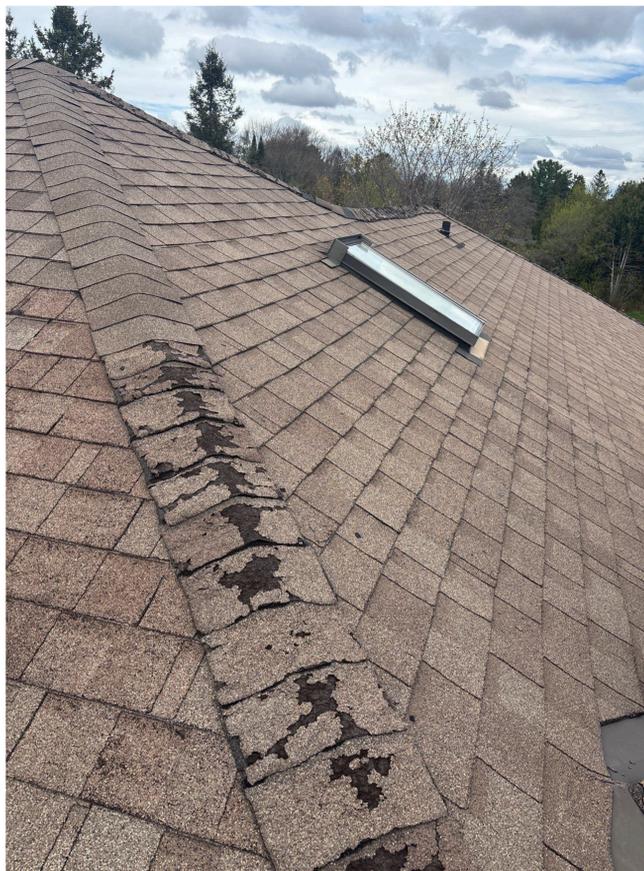
# Roof Photos

- Expired 3-tab shingles ×
- Heavy granule loss ×
- Immediate failure present ×
- Little protection against heavy weather ×

- No step flashing observed ×
- Wall flashing intact and sealed ✓
- Chimney flashing intact and sealed ✓
- Vents & skylight mostly secured, but expired ×

- ~3 nails per shingle ×
- No synthetic paper present ×
- Only 3-feet of ice & watershield present ×
- Shingle alignment is good ✓
- Low-grade shingles used ×
- Valleys secured properly ✓

This roof is in failure condition, with expired builder-grade 3-tab shingles showing severe wear, granule loss, and failing capping, along with a poor original installation lacking proper underlayment and ice & watershield, making it highly vulnerable to leaks. The skylight (moisture present) and vents are outdated, the attic is under-insulated at R30 (vs. R60 recommended), and sections of decking and eavestroughs require repair. Ice dam and leak risk are high, and immediate full replacement is recommended at \$19,800 + HST (including skylight).

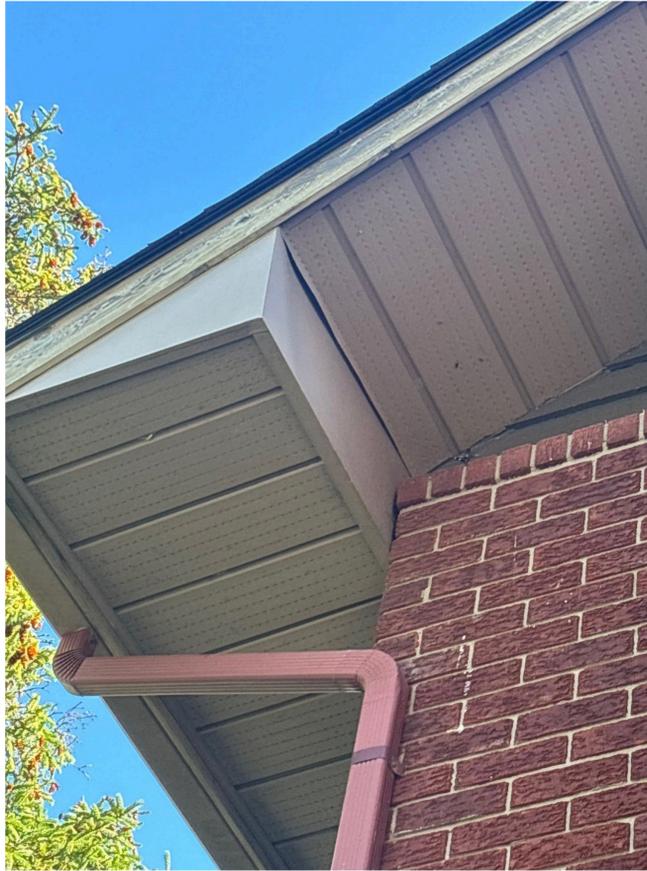
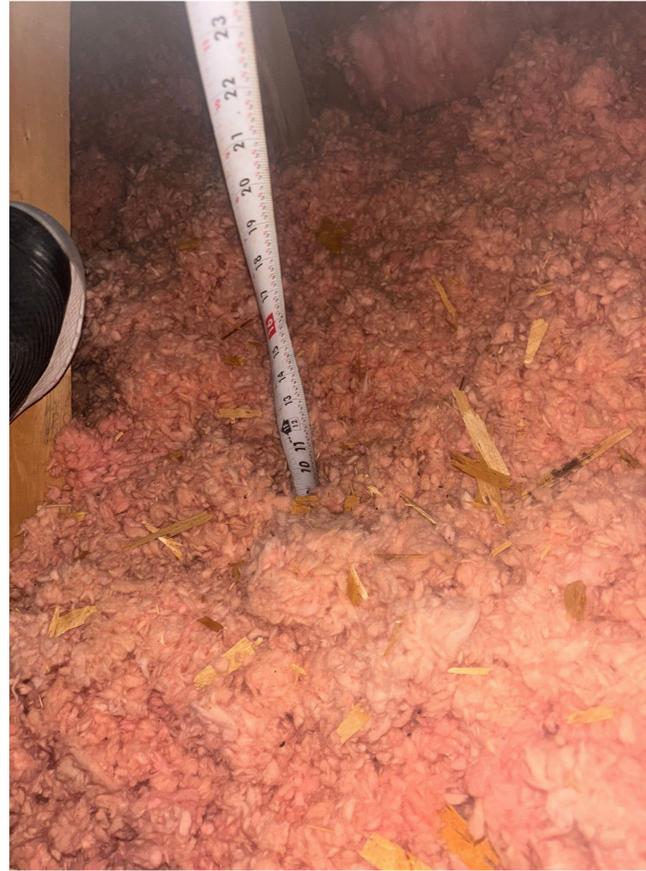
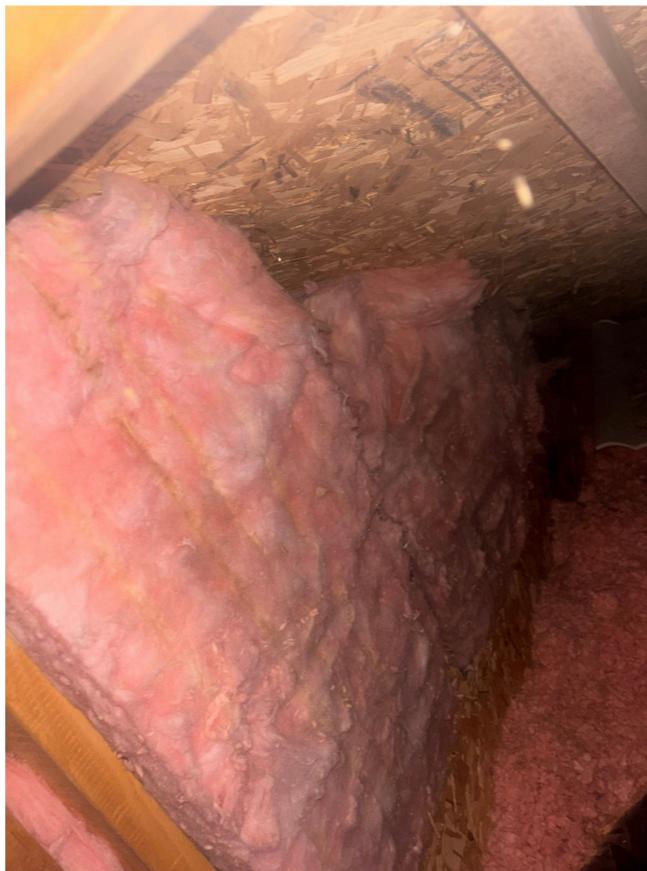
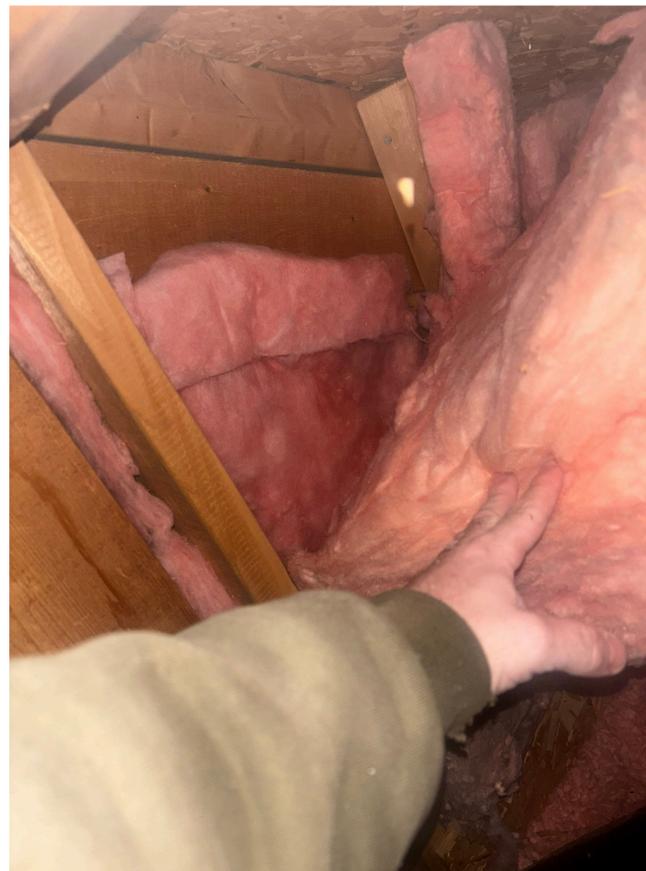
# Attic Photos

- 10" (R30) blown-in insulation measured ×
- Insulation appears evenly spread ✓
- Lots of moisture present in attic ×
- Conditions may contribute to ice dam formation and reduced roof lifespan ×
